Special Report 84-12

May 1984

Deteriorated concrete panels on buildings at Sondrestrom, Greenland

Charles Korhonen

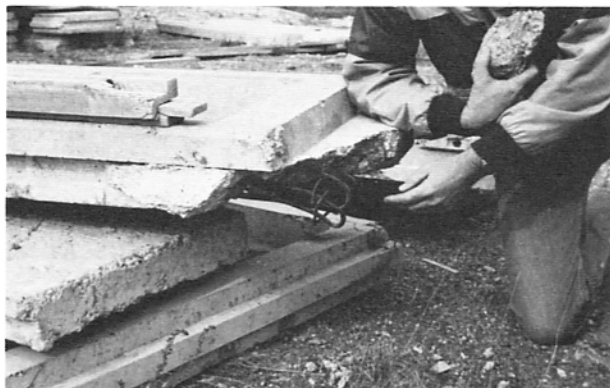
To determine its make-up, several chips of concrete from various building walls and from unused wall panels stored since 1954 near the SAB runway

(Fig. 1) were sent to WES for analysis. A microscopic examination showed that this concrete is highly susceptible to freeze-thaw deterioration in the presence of water because it was non-air-entrained. Air entraining is generally acknowledged to greatly increase the resistance to freeze-thaw deterioration.

Figure 1. Unused wall panels stored near the runway.

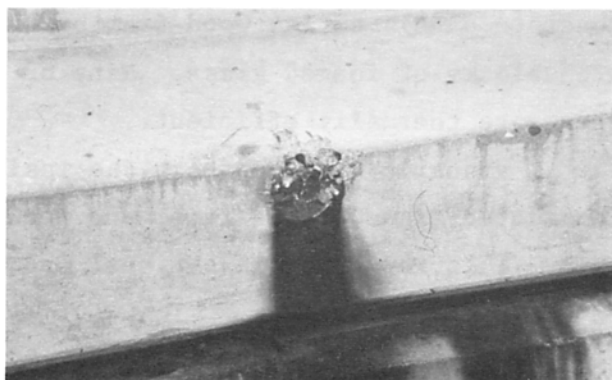
Usually when one thinks of corrosion in concrete, visions of rusted reinforcing steel come to mind. Figure 2 suggests that this is the case, as rust streaks are evident on the exterior surfaces of these buildings. However, a closer look shows that the rust is emanating from a point source, not from

Figure 2. Typical rust streak. Note the dark, iron-rich stone at its center.

cracks corresponding to reinforcement locations. I chipped out several of these areas and in each case found a rusted, iron-rich stone. Chipping deeper revealed even more of this material, except that it was not rusted at depths greater than about $3/8$ in. Unless it begins to expose more and more aggregate, this near-surface rusting is not a structural problem.

Since rust is limited to near-surface pieces of aggregate, further rusting can be eliminated by chipping out all rusted material and patching the resulting holes with an acrylic-latex-modified concrete (Fig. 9). A solution of oxalic acid and water can be used to wash off the remaining rust stains. It is best when working with acids to experiment with light applications to determine the success of various strengths of solution. Also, the surrounding concrete should be wetted to minimize etching.

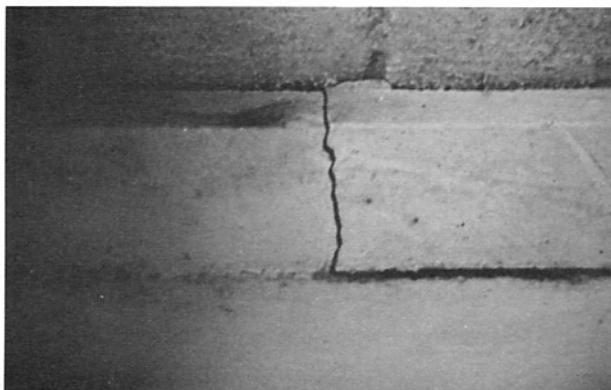
My measurements and observations suggest that most of these buildings have settled differentially. Cracks and separations in the structural framework at several locations were evidence of this. For example, in the corner of one building a section of grade beam (Fig. 3a) had cracked and separated from the floor slab by as much as $1/4$ in. but had remained in contact with the floor along the rest of its length. In another case, an equipment support rod that was securely bolted to the ceiling and floor had bowed (Fig. 3b). A comparison of the bowed and unbowed rod heights showed that the ceiling-to-floor distance had decreased by $1/16$ in. These and similar movements are considered responsible for developing shear forces within many of the concrete panels, causing them to crack across their widths. Figure 4 shows a typical panel-wide crack. The diagonal nature of these cracks indicates a shear-type failure mode.

a. Grade beam cracked and separated from floor, leaving a $1/4$ -in. crack.

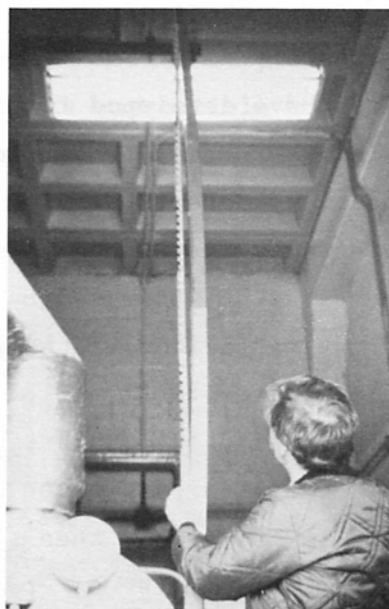
b. Bowed equipment support rod, representing a $1/16$ -in. movement.

Figure 3. Measurements that suggest buildings have settled differentially.

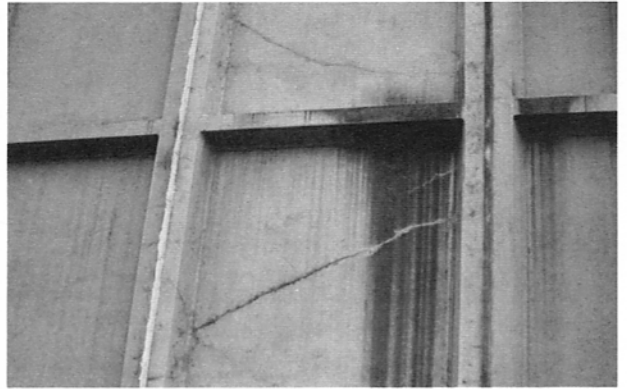
However, it is difficult on the basis of only one site visit to predict if the foundations are still moving. (Monitoring devices should be installed on several cracks to determine that.) But because these cracks are reported to have developed shortly after the buildings were constructed and because they have remained tight (Fig. 4), I do not expect these cracks to worsen significantly in the near future.

Figure 4. Panel-wide crack.

The cracks that run the width of many panels (Fig. 4) and those that occur at the vertical edge of other panels (Fig. 5a) can be cosmetically repaired with a coating. Several paint-like cement-based products are available that will adhere very well if the concrete surface is first sandblasted.

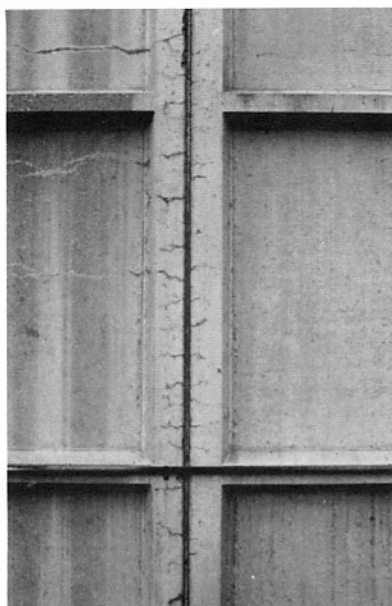
As the temperature changes, the concrete panels that clad these buildings are constantly expanding and contracting. To accommodate this movement each wall panel has been separated by a 3/8-in. joint, weather sealed with a flexible metal waterstop. Some joints have also been filled with a rigid, cement mortar. Wherever this mortar has been used, the panels have not been free to expand. As a result, stresses have built up to the point where the panel edges have developed two types of cracks along these joints: short hairline cracks perpendicular to the panel edge (Fig. 5a) and diagonal cracks at the panel corners (Fig. 5b).

The stress σ developed in such a restrained member due to a change in temperature can be estimated by multiplying the member's modulus of elasticity E by its coefficient of thermal expansion α and the change in temperature ΔT it is subjected to ($\sigma = E \alpha \Delta T$). If we assume that 1) the concrete panels were installed at 55°F and attain a summer temperature of 85°F, 2) their coefficient of thermal expansion is 6.5×10^{-6} in./in.°F, and 3) their modulus of elasticity is 4×10^6 psi, then the stress would be 780 psi; this is too small to crack structurally sound concrete. But this assumes, of course, that the 780 psi is uniformly distributed, which, obviously, it is not. Both kinds of stress cracks do not occur together on the same panel but are part of an active process that can easily be solved by removing the cement mortar between panels.

a. Hairline cracks along panel edges.

Before any cosmetic repairs are made, all cement mortar between panels must be removed to avoid further stress cracking. If a sealant must still be used in those joints, an elastomeric material would be best. Polysulfides, polyurethanes and silicones are excellent choices for working joints because

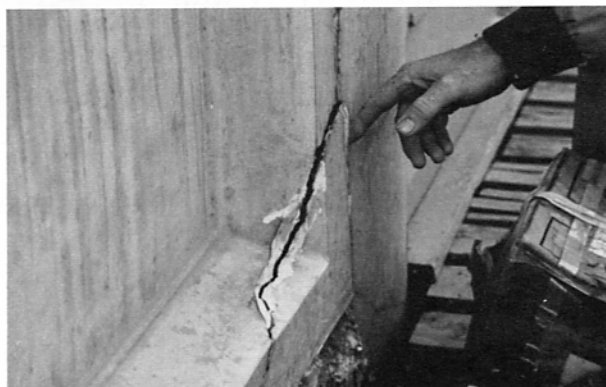
b. Diagonal cracks that have spalled off panel corners.

Any spalling, as shown in Figures 5b and 6, can be patched with an acrylic-latex-modified concrete using the following procedure:

- a) Remove all unsound concrete with a light-weight chipping hammer.
- b) Clean chipped surface with high-pressure water or sandblasting to remove oils, grease, dirt, sealants and anything that would prevent good adhesion. If sandblasting, use compressed air to blow off any fines left behind.
- c) Lightly dampen the surface with water without creating puddles.
- d) Mix and place the patch material, closely following the manufacturer's instructions.

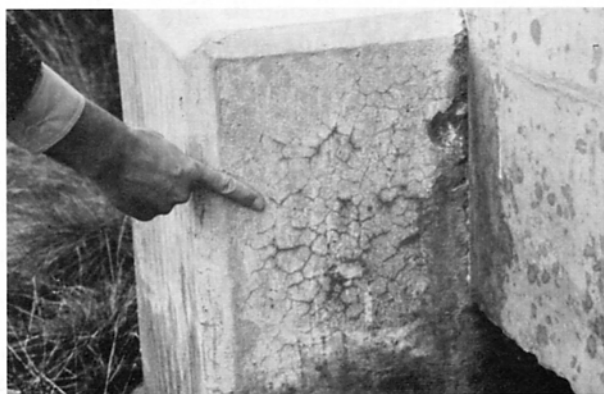
Frost damage is rare on these buildings. About the only place it is noticeable is on the grade beams (Fig. 6). This is somewhat surprising because the laboratory results showed that this concrete is susceptible to freeze-thaw deterioration. The main reason why this concrete has survived the low temperatures so well is that the climate at Sondrestrom is very dry.* Dry concrete, whether it is entrained with air or not, is not deteriorated by freezing.

Figure 6. Minor freeze-thaw deterioration. The lime deposits indicate wetting.

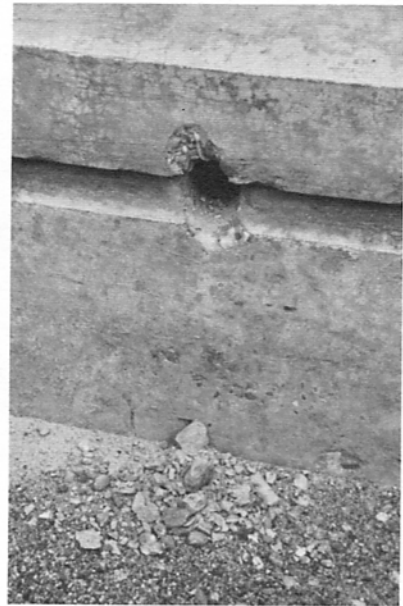
To determine if it did, I probed into several weepholes and peered into other larger holes previously cut into the walls. In many cases the weepholes were filled with chips of concrete (Fig. 7a), and the back sides of those panels that could be reached through the larger holes (Fig. 7b) were much rougher than the back sides of the panels stored near the runway (Fig. 1). This convinced me that the wall cavities were being eroded by frost action fed by interior building moisture.

a. The chips of concrete in the foreground came out of this weephole.

It is obvious from the erosion taking place in the wall cavities that water vapor, generated within the buildings, enters the walls faster than it can escape and condenses on the inside surface of the outer leaf. This erosion can be minimized by adding a vapor-resistant material to the inside wall surfaces. On some buildings this has already been done, so no further work

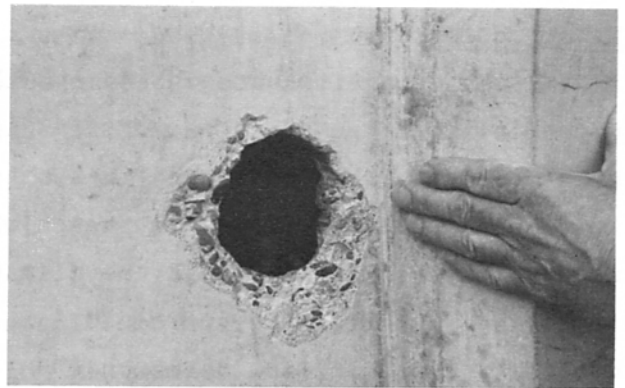
b. Reaching inside holes such as this one revealed that the back sides of some panels were very rough.

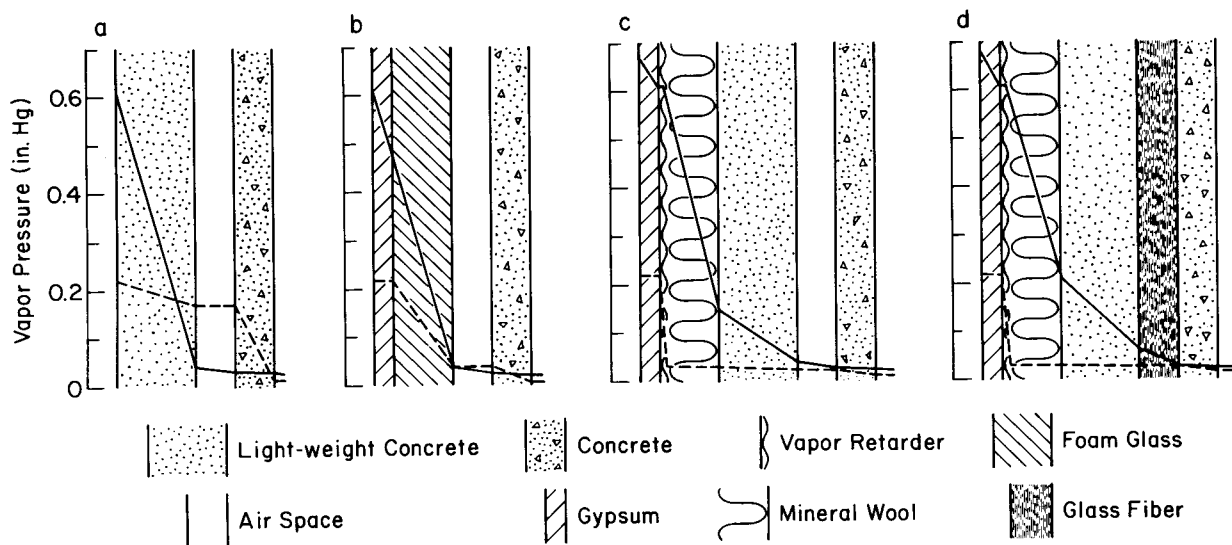
Figure 8 compares the vapor pressure profile through each of these walls as outlined in ASHRAE (1981). It was assumed that the walls were exposed to indoor conditions of 70°F and 30% relative humidity and outdoor conditions of

Figure 8. Vapor pressure profiles through four wall cross sections. Moisture condenses when the actual vapor pressure (dotted line) exceeds the vapor pressure of saturated air (solid line). The warm side of each wall is on the left.

-10°F and 70% relative humidity. As can be seen, condensation is more likely to occur in the two walls without a warm-side vapor retarder (Fig. 8a,b). It was in these walls that I found the most debris. Also, it was on these buildings that the wall panels seemed to be a bit more cracked. Thus, it appears that much of the deterioration of these buildings can be alleviated by adding a vapor retarder on the warm side of the walls.

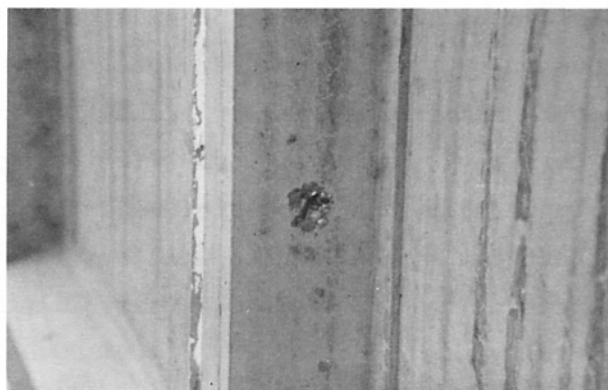
Figure 9. Hole remaining after an iron-rich stone has been chipped out.
